SITE INVESTIGATIONS
FOR RESIDENTIAL DEVELOPMENT
ON THE PORT HILLS,
CHRISTCHURCH

A thesis
submitted in partial fulfilment
of the requirements for the Degree
of
Master of Science in Engineering Geology
in the
University of Canterbury
by
Barry J. McDowell

University of Canterbury
1989

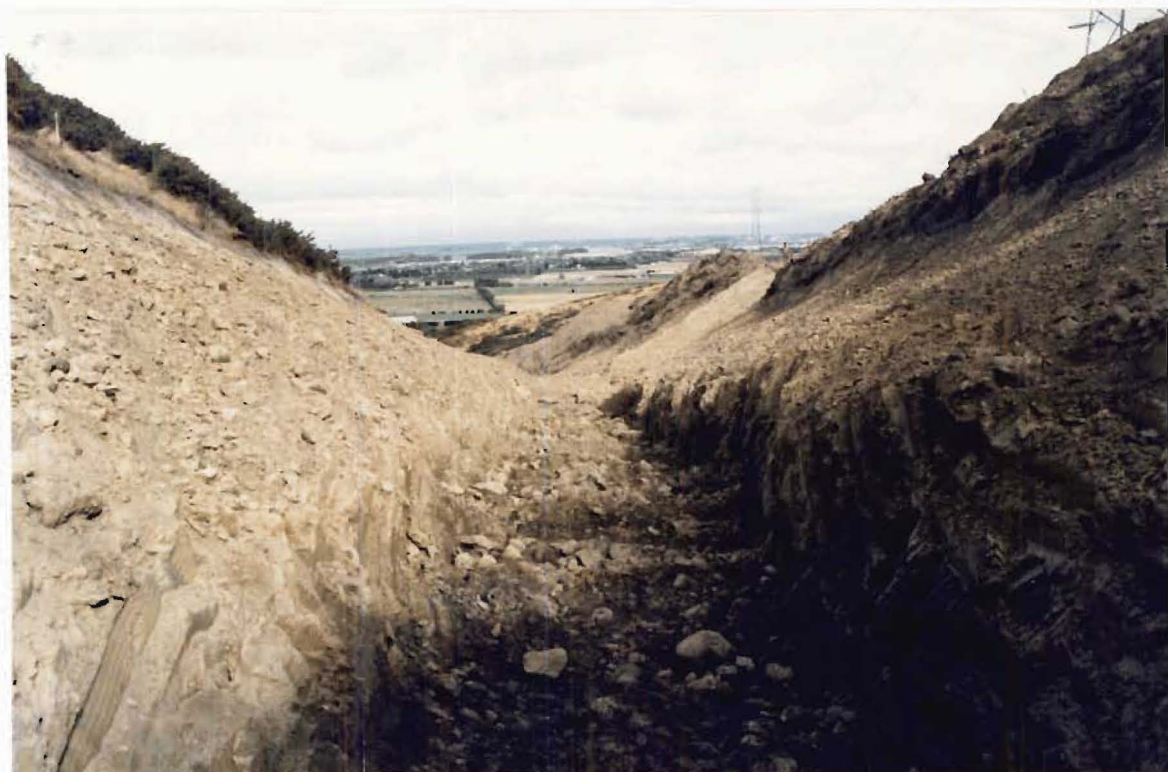
A backhoe cleared topsoil and vegetation from the gully walls, cut a 3m wide channel in the floor of the gully, and a track down the flank to allow machinery access. The insitu loess was also ripped to give improved bonding with the fill material (Figure 4.8). The first 1/3 of the fill material came from cut area B, with the remaining 2/3 sourced from cut area D. Topsoil and dry loess was removed from cut areas by scrapers and bulldozer. Moist insitu loess ($W=10-15\%$) was cut and transported by scrapers, spread 20-40cm deep by bulldozer and compacted by a sheepsfoot wheeled compactor (Figure 4.9). After placing 2-3m of fill a trench was dug along the gully center line to place a temporary drainage pipe. The temporary pipe was to accommodate any surface water flow in the gully during construction of the fill. During the final stages of fill construction an intake structure for the subdivision stormwater system was built in the gully upstream of the fill, and the temporary pipe was blocked up. The completed fill has a downstream batter slope of approximately 20° and 15m high, and an upstream batter slope of approximately 30° and 3m high. Maximum vertical thickness of fill is approximately 7m.

Figure 4.8 : View Down Gully Prior to Filling. Channel cut at base of gully is to allow machinery access for initial filling

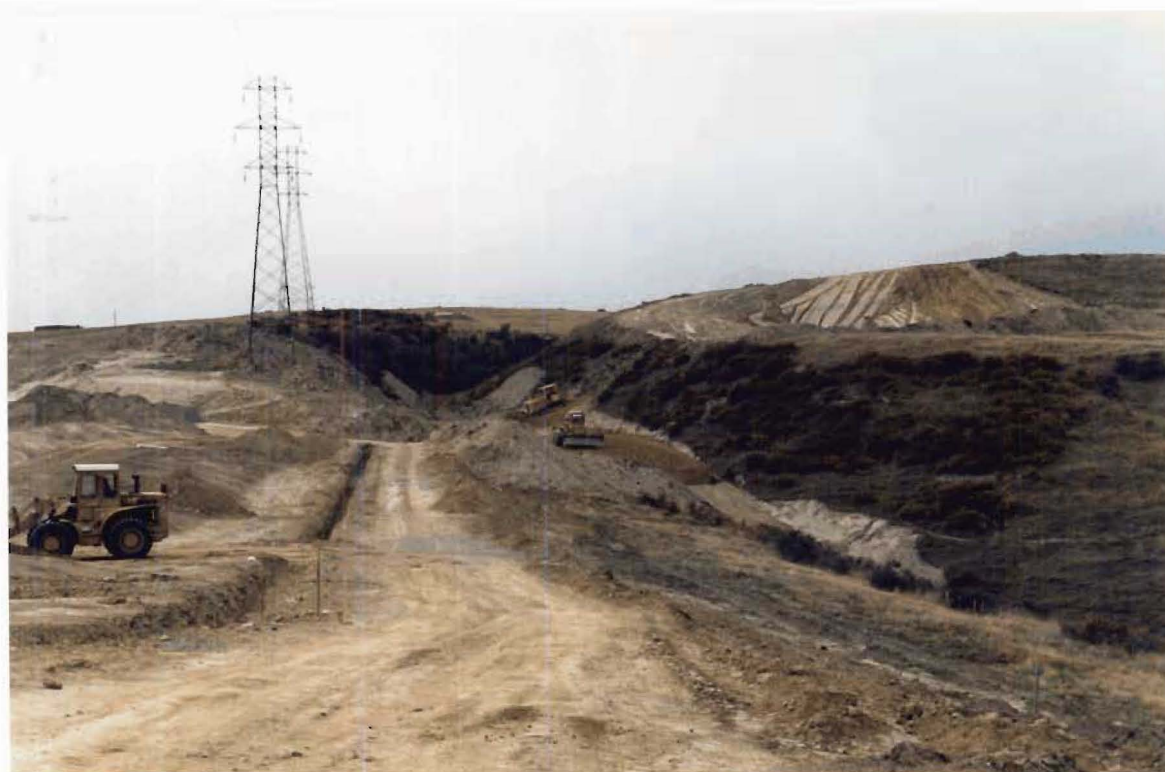
Figure 4.9 : View Up Road Extension. Bulldozer spreading and sheepfoot compactor rolling fresh loess fill sourced from cut area D in background. Dark colour of fresh loess indicates moisture content in the 10-14% range

Moist insitu loess cut at W=10 to 14% will compact at W=8 to 12% (moisture loss due to transport and spreading of lift) forming a massive evenly compacted fill, with dry density significantly higher than insitu

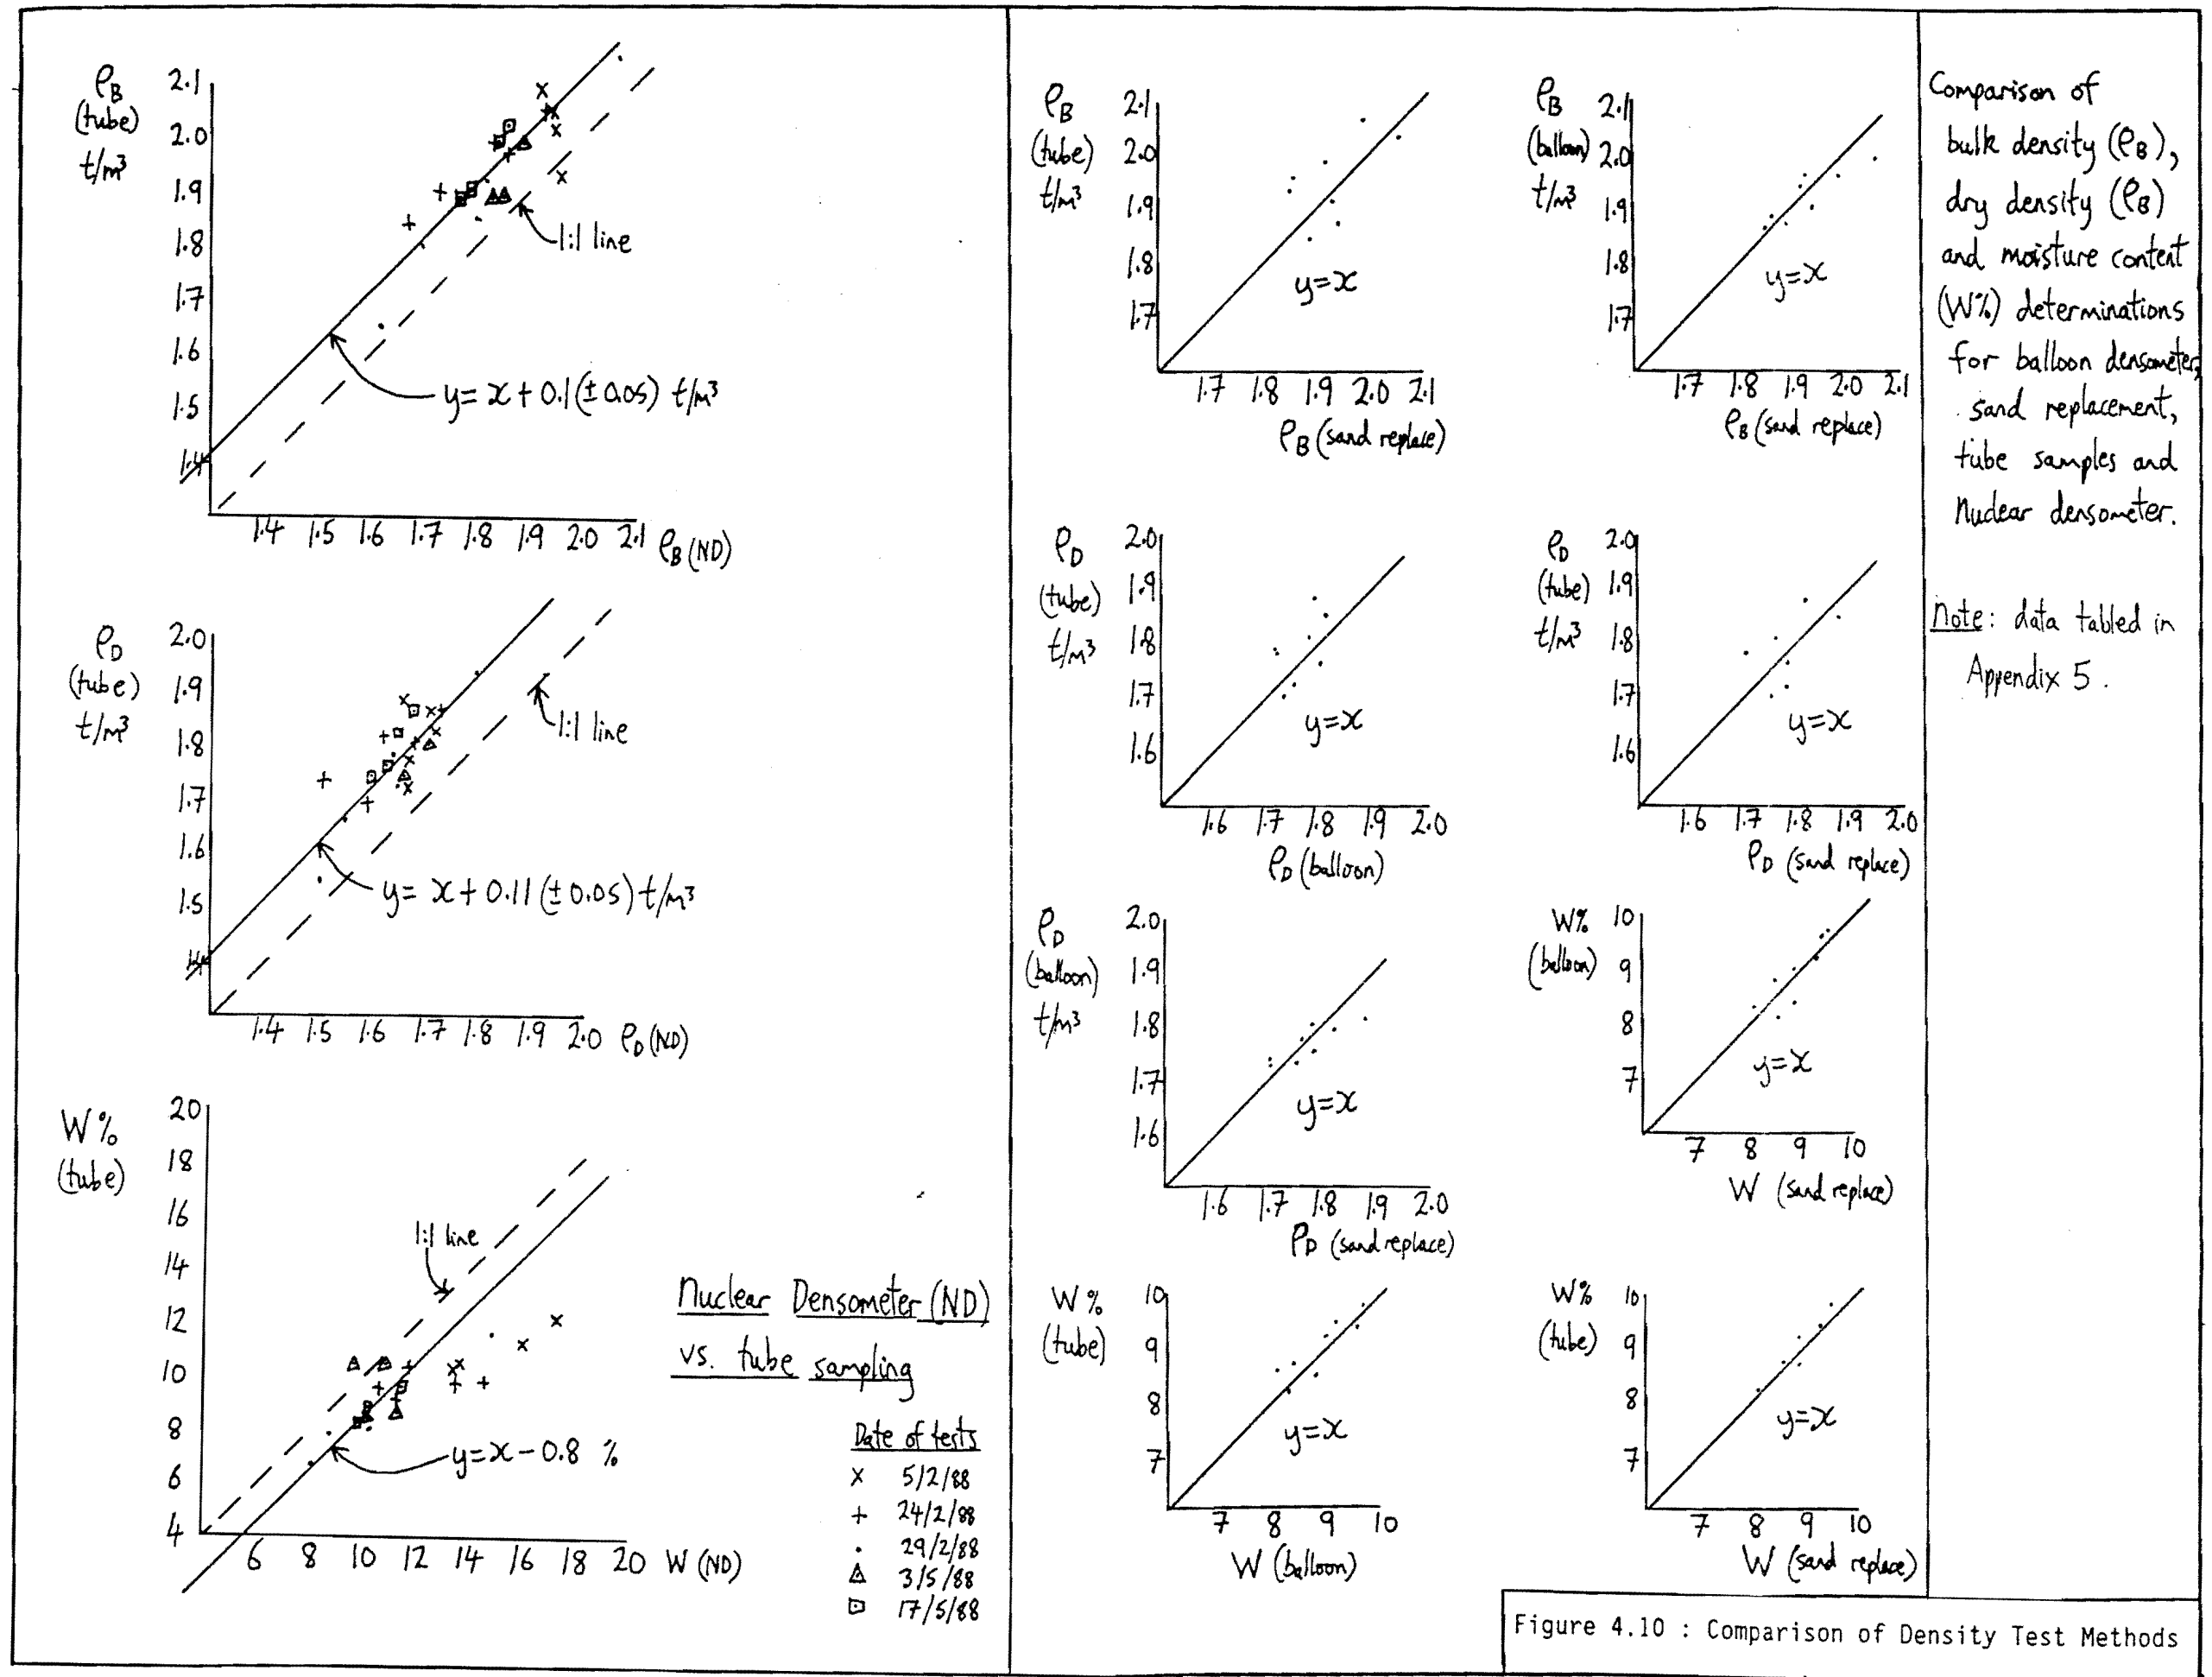
Figure 4.10 : Comparison of Density Test Methods

Comparisons of results have been made by simply plotting bulk densities, dry densities and moisture contents for each of the methods used side by side (see figures 4.10 and 4.11) Moisture contents for the physical tests (BD, SR, tube) show very little scatter from a 1:1 correlation, which might be expected as all methods use a wet weight-oven dry-dry weight procedure to determine moisture content (W%).

Density comparisons for the physical tests show up a difference in sampling. The BD and SR tests both require excavation of a 100mm diameter by 100mm deep hole in the fill. The 35mm diameter by 150mm long tube samples a smaller surface area and a potentially greater number of layers, thereby resolving minor local variations in density that are averaged out by the larger diameter, larger volume BD and SR samples. A BD vs. SR plot shows little scatter about a 1:1 correlation line, while plots of BD vs.
